Report No. CG-D-11-97

## **Development of Composite Components for the CCN-150-5C Transfer Pump**

H. K. Telegadas  
and  
George F. Wilhelmi

Final Report  
November 1996

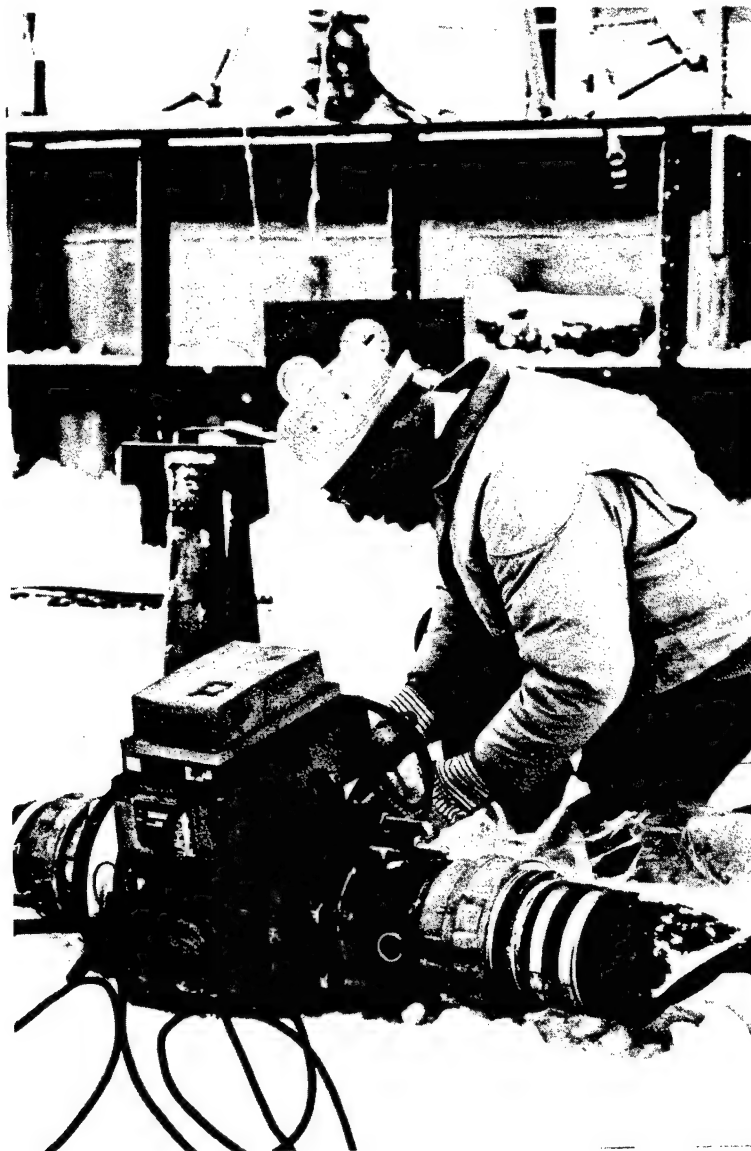
Fig. 13. Photograph of the magnetic flow meter.

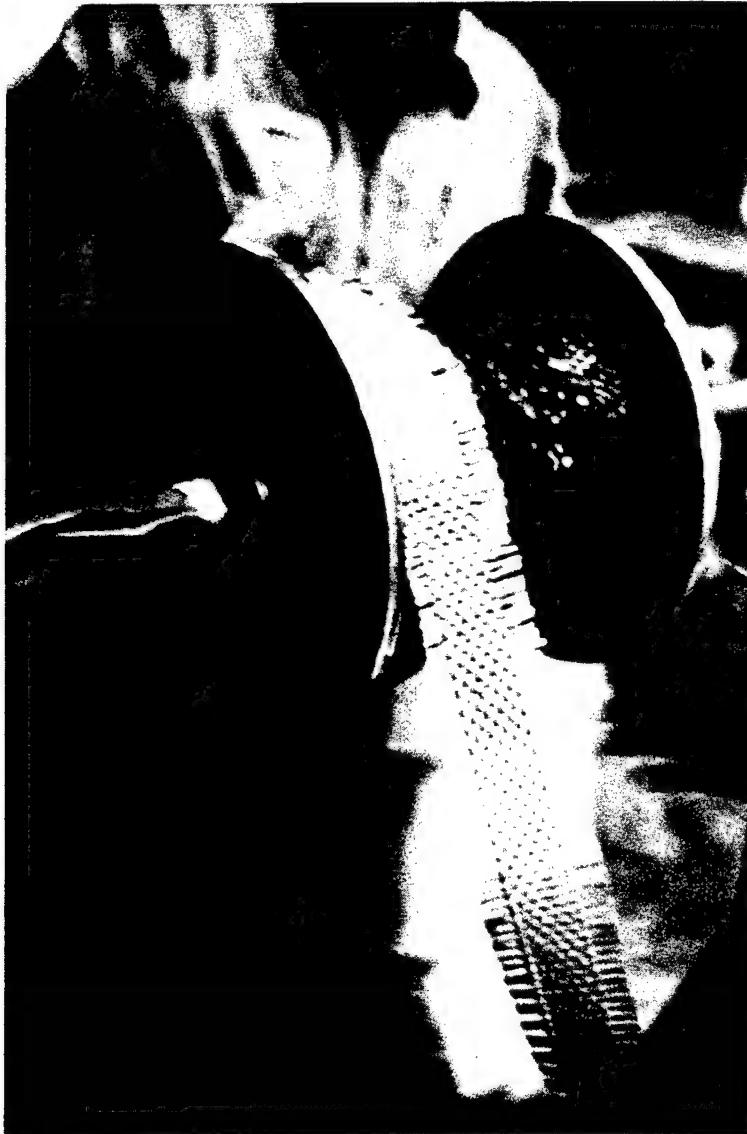
Fig. 25. Fabricating the composite suction bell, applying a woven roving layer.

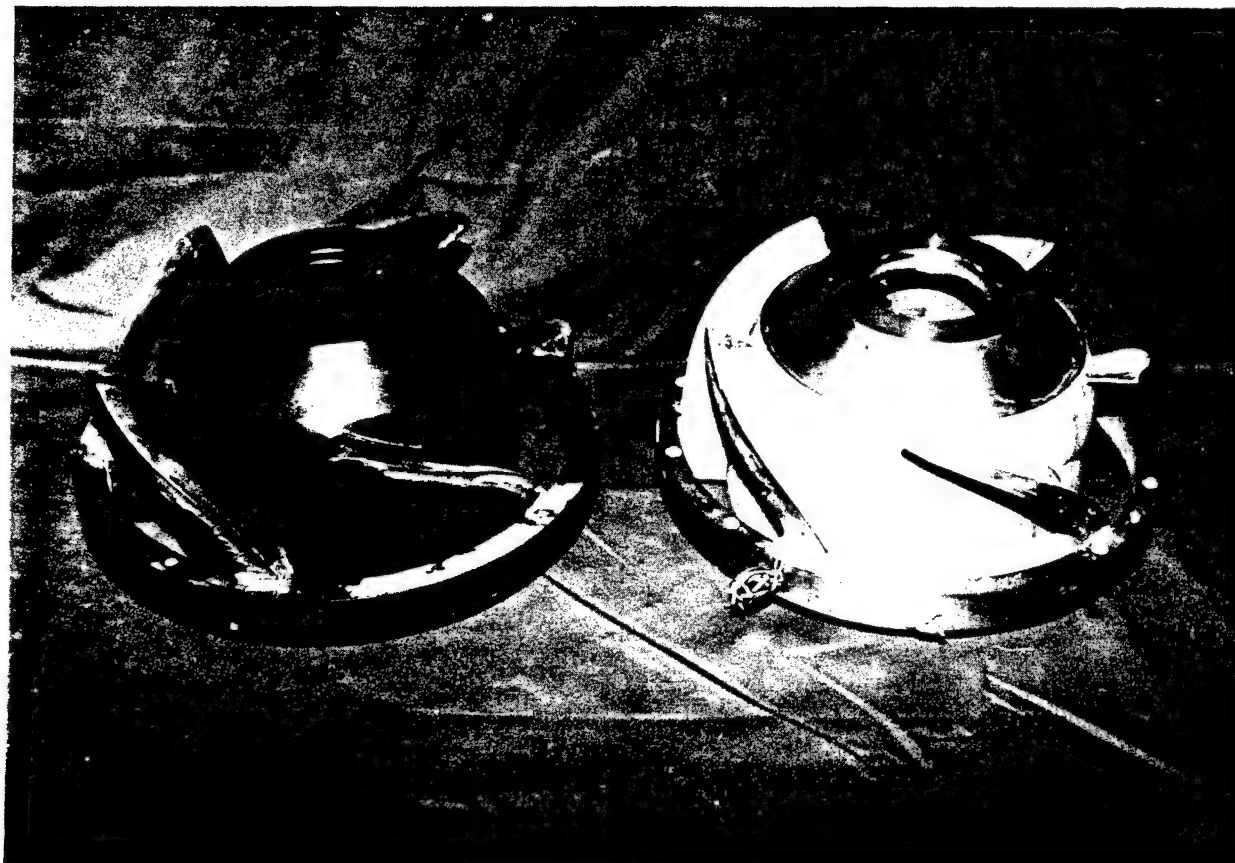
Fig. 34. Photograph of the finished composite pump bowl next to its metallic counterpart.
